Home Inspection Report

Prepared by: Mike McGhghy
Aerial Advantage Property Services
(319) 795-6703

*Prepared for: John Smith
Lake of the Ozarks , MO*

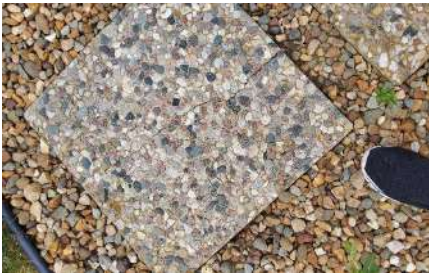
1. Walks: Concrete, Paver - Paper leading to back deck stairs cracked, this is typical no reason to be alarmed FYI. Also no trip hazard noted.

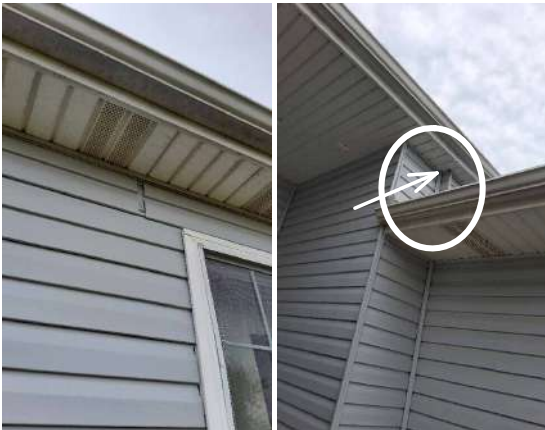
2. Exterior Exterior Surface Type: Vinyl siding - Siding cut short top row rear of the house. Gap in the siding exposing vapor barrier. Recommend replacing the section of vinyl siding as soon as practical.

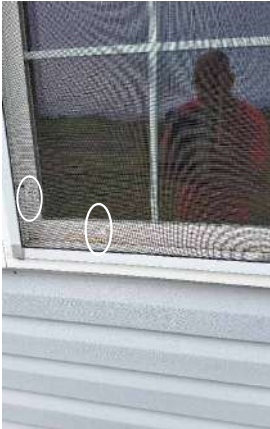
3. Window Screens: Vinyl mesh - Screen is torn and will need repair. Rear of the house above basement window well.

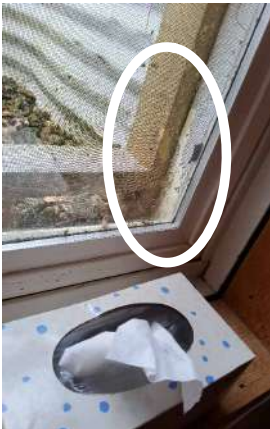
4. Sub Basement Windows: Vinyl slider - Window seal broken or damaged, North and Northwest basement windows. Condensation inside panes. Recommend replacement of the effected panes, As soon as practical.

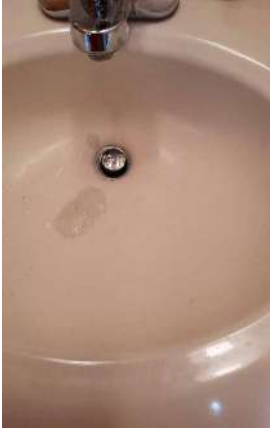
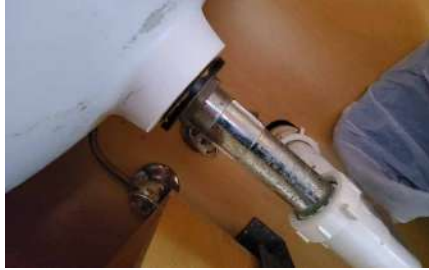
5. 1st floor main Bathroom Sink/Basin: One piece sink/counter top - Previous repairs done on sink seems to be serviceable think about replacing some time. If not only for cosmetic reasons.

Not leaking at this time although it is cracked underneath as well I recommend replacement as soon as practical.

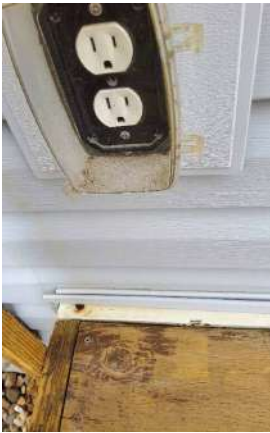
1. Exterior Electric Outlets: 110 VAC - Non-GFCI outlet, real house beside patio door I recommend replacing with GFCI outlets.

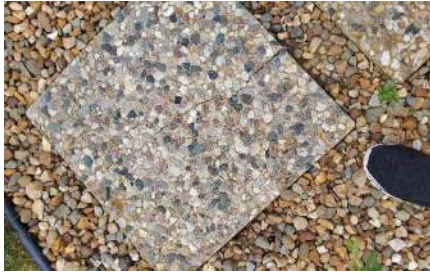
- 1. Acceptable Driveway: Concrete
- 2. Marginal Walks: Concrete, Paver - Paper leading to back deck stairs cracked, this is typical no reason to be alarmed FYI. Also no trip hazard noted.

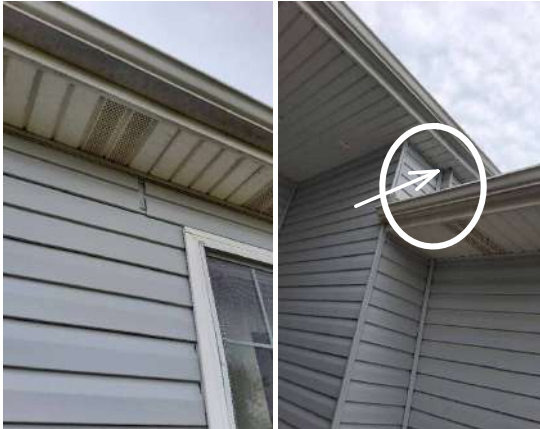
1. Acceptable, Marginal Type: Vinyl siding - Siding cut short top row rear of the house. Gap in the siding exposing vapor barrier. Recommend replacing the section of vinyl siding as soon as practical.

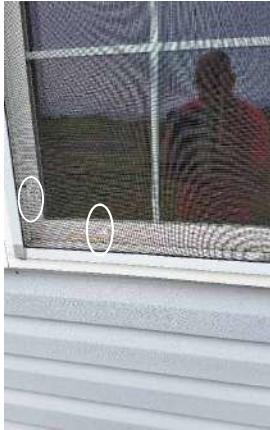
Window Screens: Vinyl mesh - Screen is torn and will need repair. Rear of the house above basement window well.

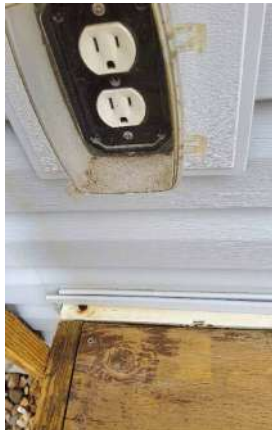
13. Acceptable, Defective Exterior Electric Outlets: 110 VAC - Non-GFCI outlet, rear house beside patio door I recommend replacing with GFCI outlets.

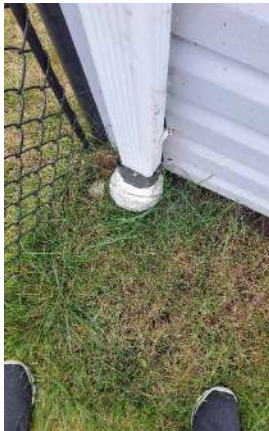
Downspouts: Aluminum - Plastic boot covering downspout entry to drainage system covered with aluminum tape probably cracked. Consider replacing that cover FYI.

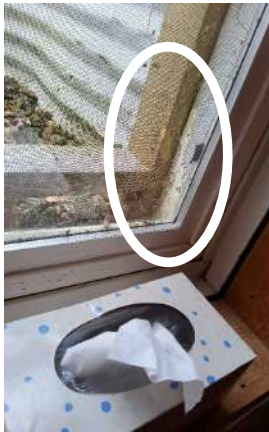
- 1. Acceptable Ceiling: Exposed framing
- 2. Acceptable Walls: Exposed framing
- 3. Acceptable Floor: Poured
- 4. Acceptable Floor Drain: Not visible
- 5. Marginal Windows: Vinyl slider - Window seal broken or damaged, North and Northwest basement windows. Condensation inside panes. Recommend replacement of the effected panes, As soon as practical.

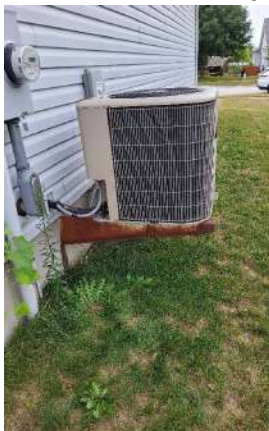
3. Acceptable Exterior Unit: Suspended - Beans suspending the unit rested I recommend painting to stop the corrosion and prevent future.

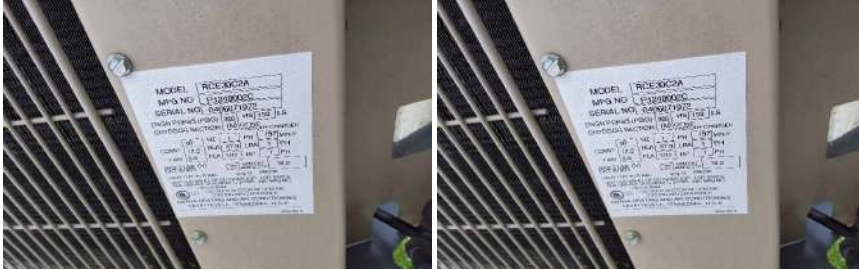
4. Manufacturer: Amana

5. Model Number: RCE30C2A Serial Number: 040-607-1972

6. Area Served: Whole building Approximate Age: 17 years, Mfg date of 06/2004 is at end habits designed lifespan, although it is in good working condition and has been maintained, I recommend full evaluation and qualified HVAC contractors, replacement as soon as practical.

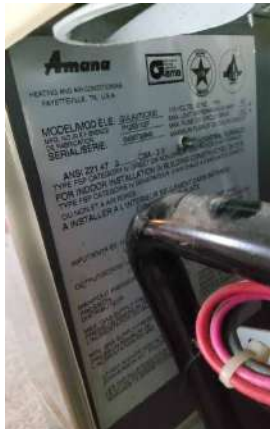
1. Acceptable Heating System Operation: Appears functional - Unit is beyond its designed life, seems to be working properly at time of this inspection. I recommend further evaluation from a qualified HVAC professional. replacement when practical

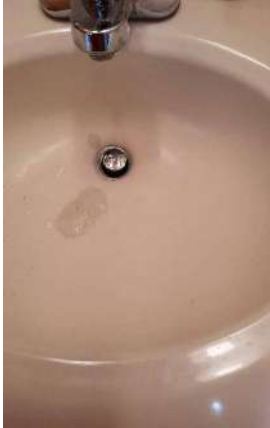
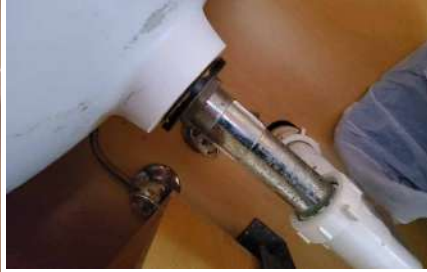
Sink/Basin: (continued)

8. Acceptable, Marginal Sink/Basin: One piece sink/counter top - Previous repairs done on sink seems to be serviceable think about replacing some time. If not only for cosmetic reasons.

Not leaking at this time although it is cracked underneath as well I recommend replacement as soon as practical.
